RC
1042
.M38
1990a
c.2

Department
of Transportation
National Highway
Traffic Safety
Administration

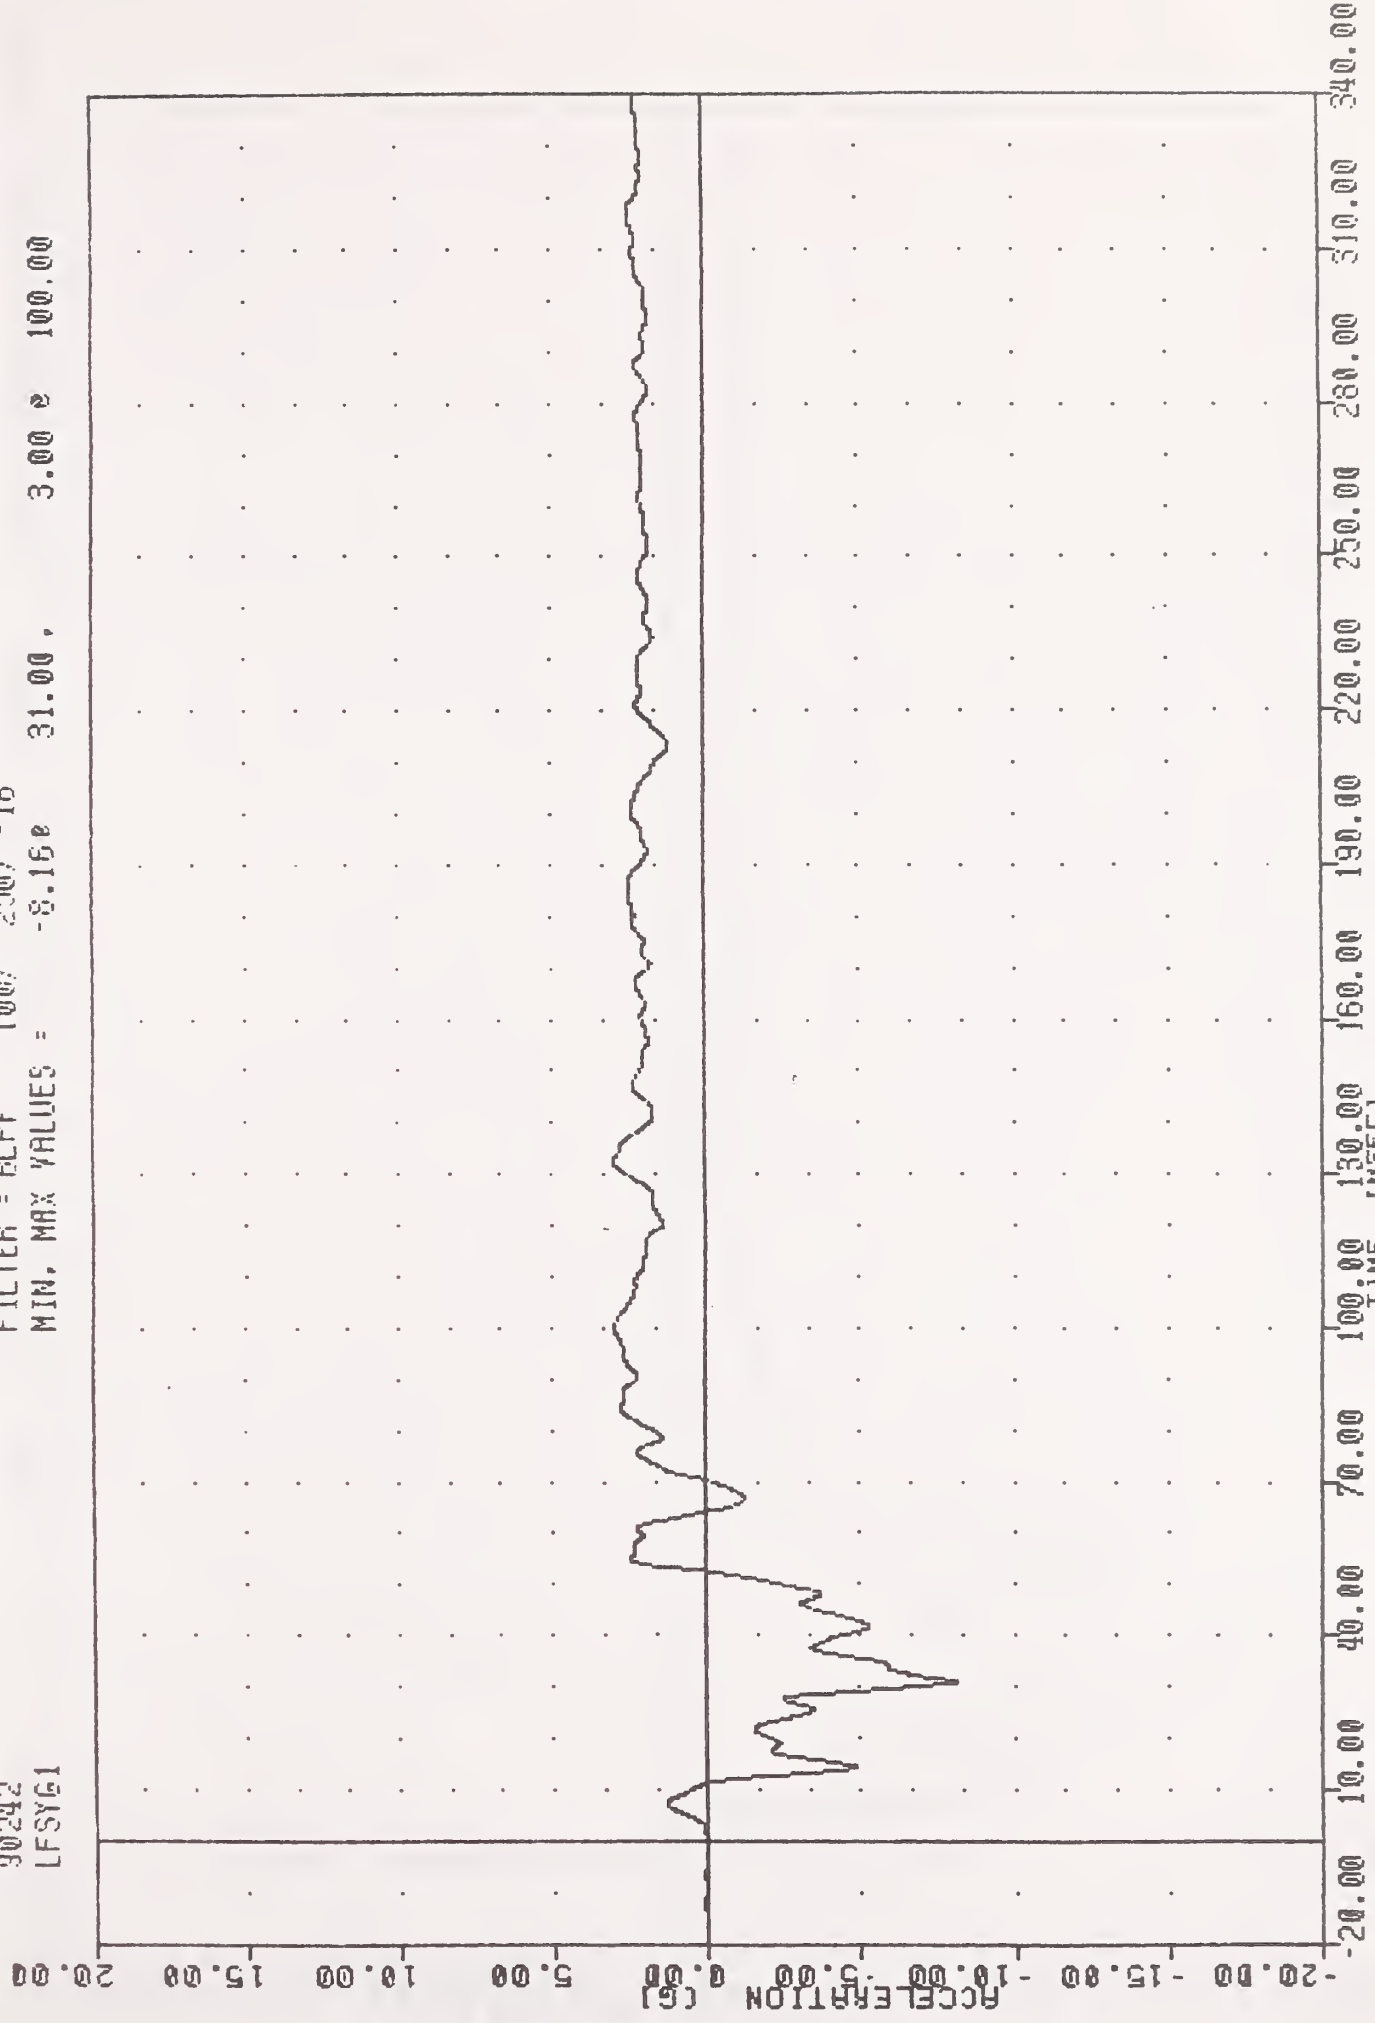
CONTOURED MOVING BARRIER INTO FORD ESCORT AT 28.1 MPH #2
 LEFT FRONT SILL Y-AXIS ACCELERATION

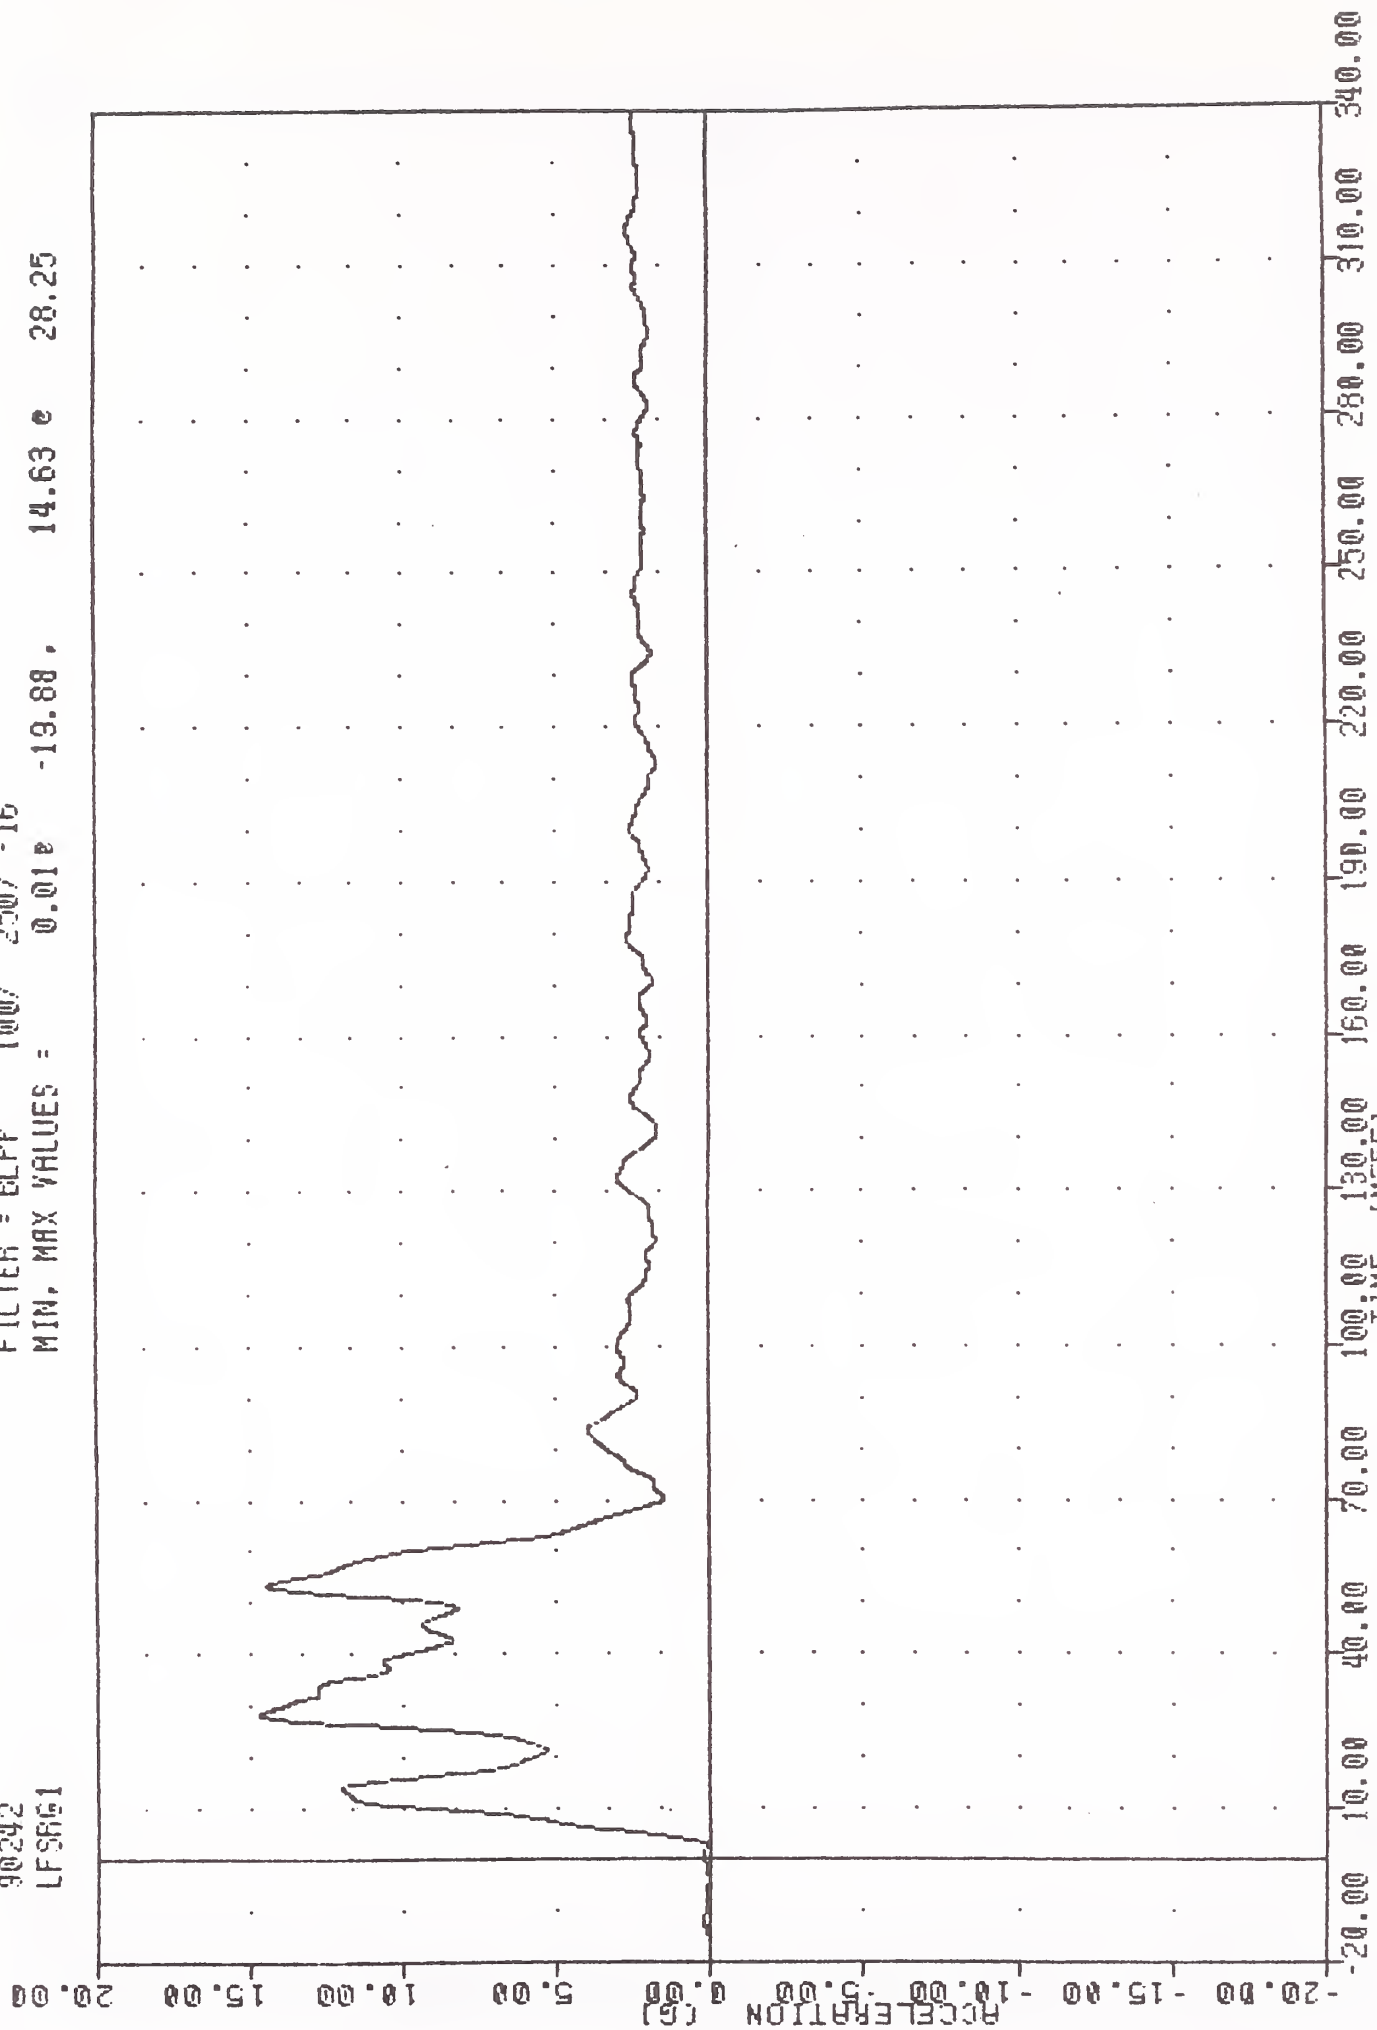
CONTOURED MOVING BARRIER INTO FORD ESCORT AT 28.1 MPH #2
LEFT FRONT SILL RESULTANT ACCELERATION

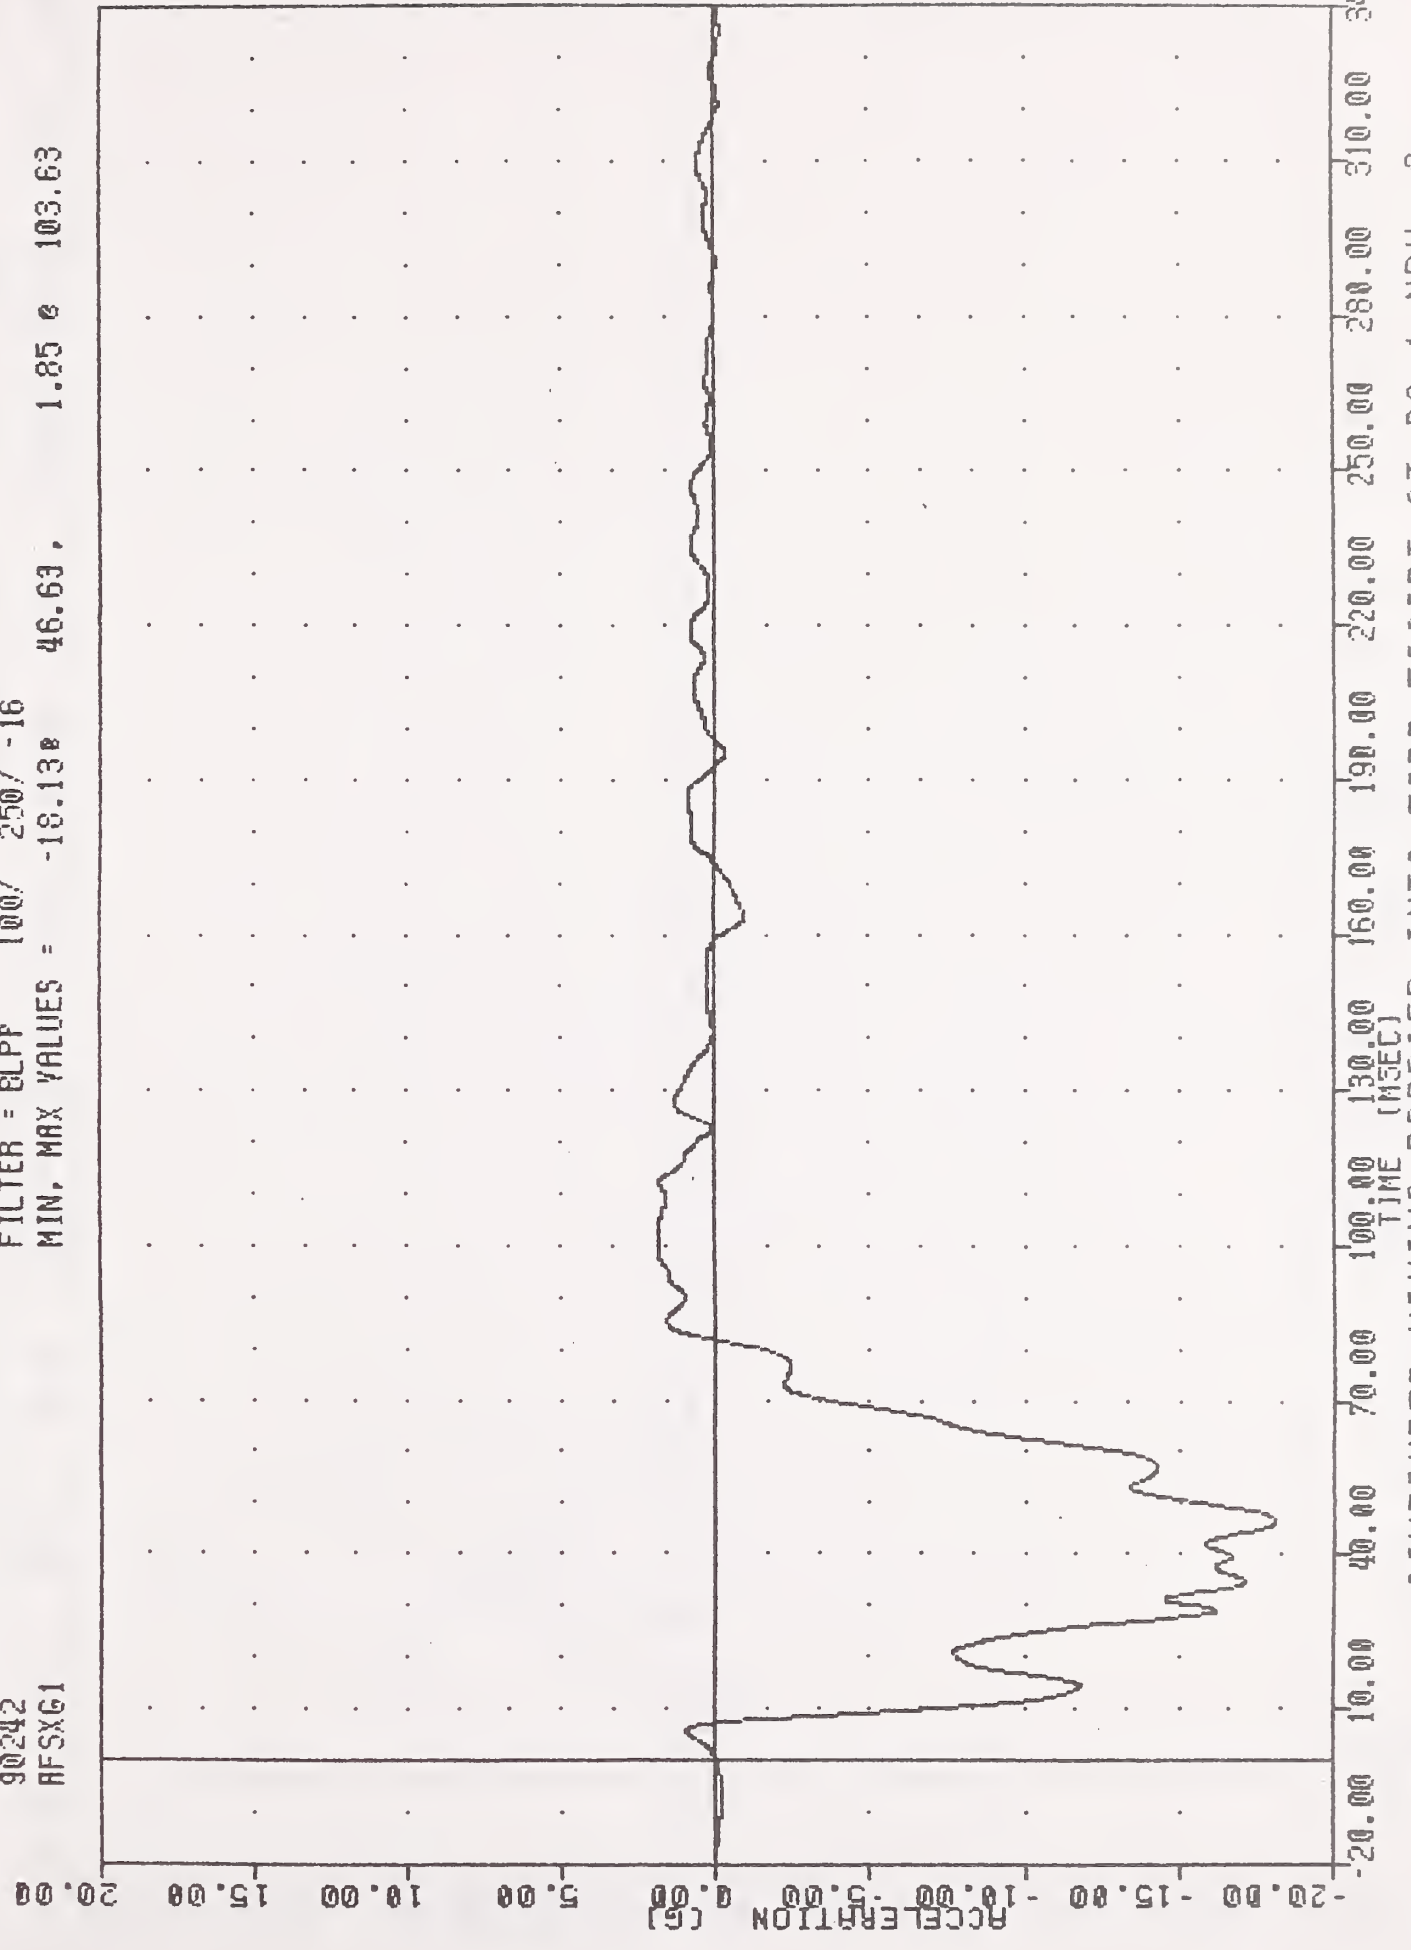
CONTOURED MOVING BARRIER INTO FORD ESCORT AT 28.1 MPH #2
 RIGHT FRONT SILL X-AXIS ACCELERATION

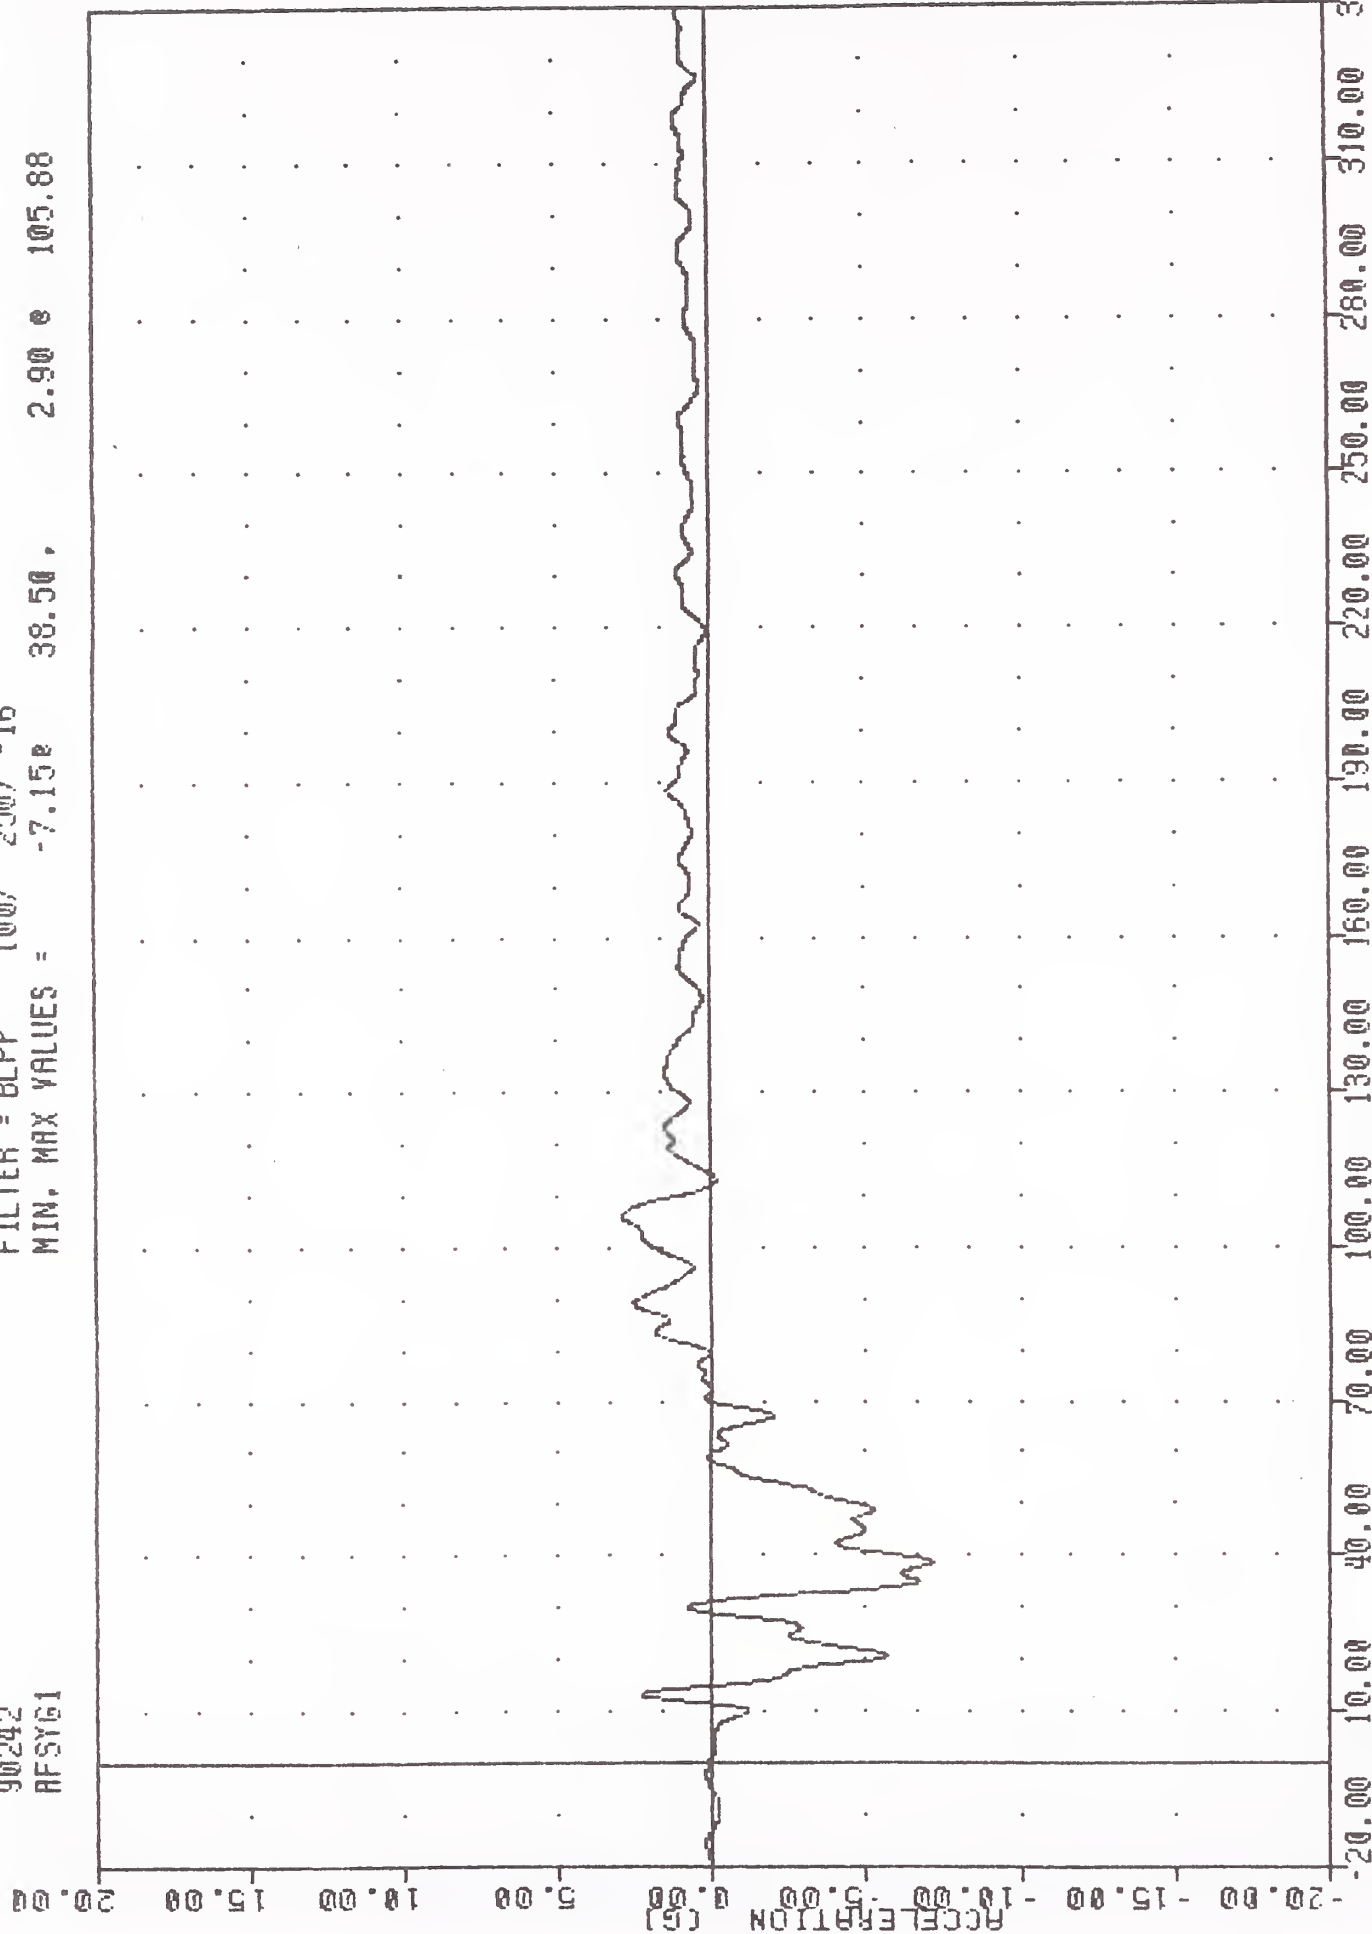
CONTOURED MOVING BARRIER INTO FORD ESCORT AT 28.1 MPH #2
RIGHT FRONT SILL Y-AXIS ACCELERATION

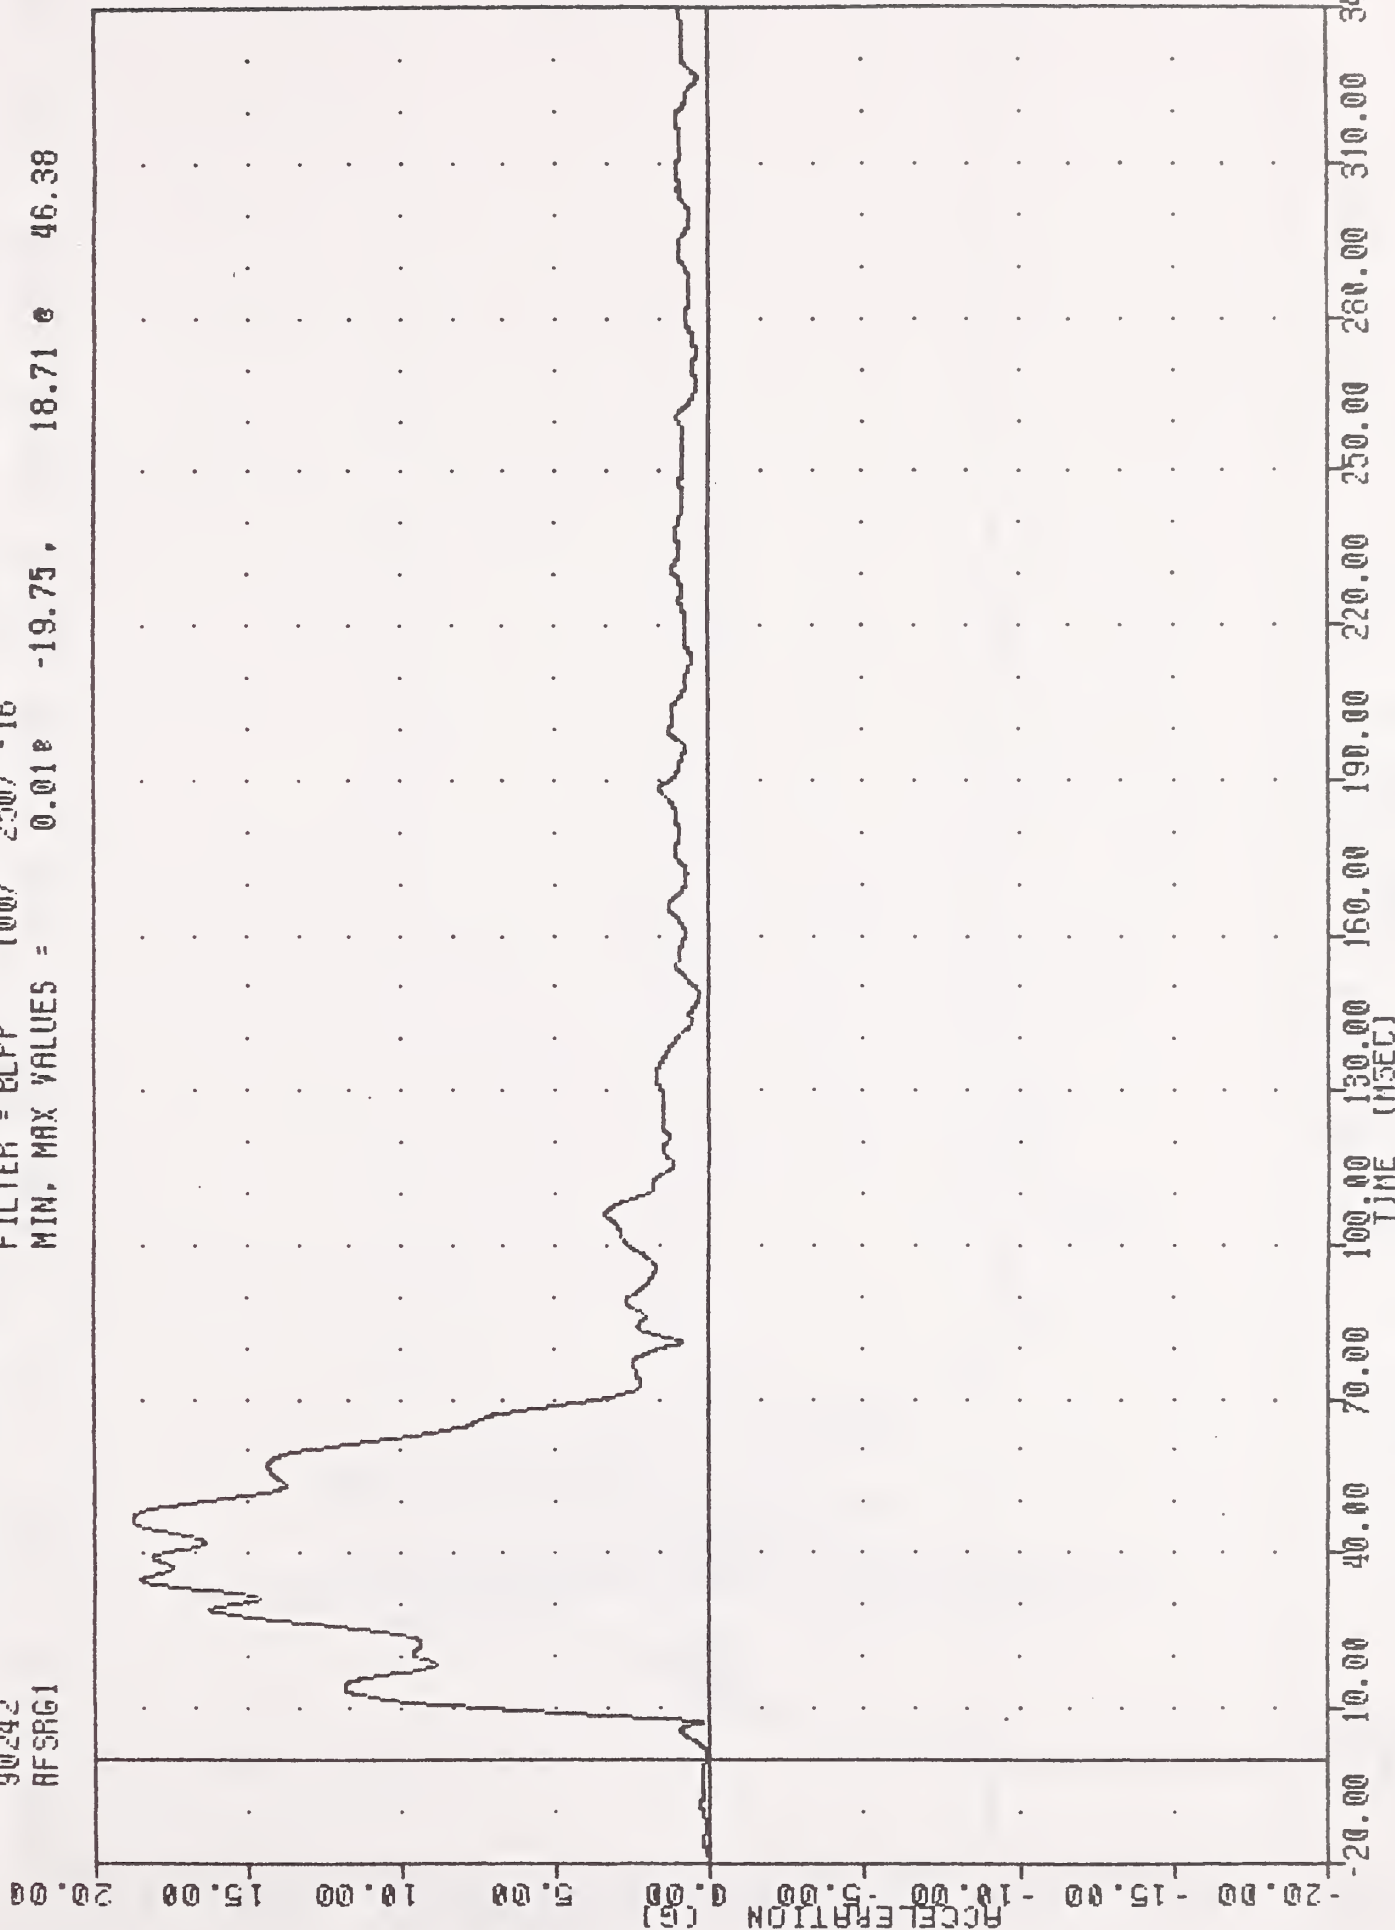
CONTOURED MOVING BARRIER INTO FORD ESCORT AT 28.1 MPH #2
RIGHT FRONT SILL RESULTANT ACCELERATION

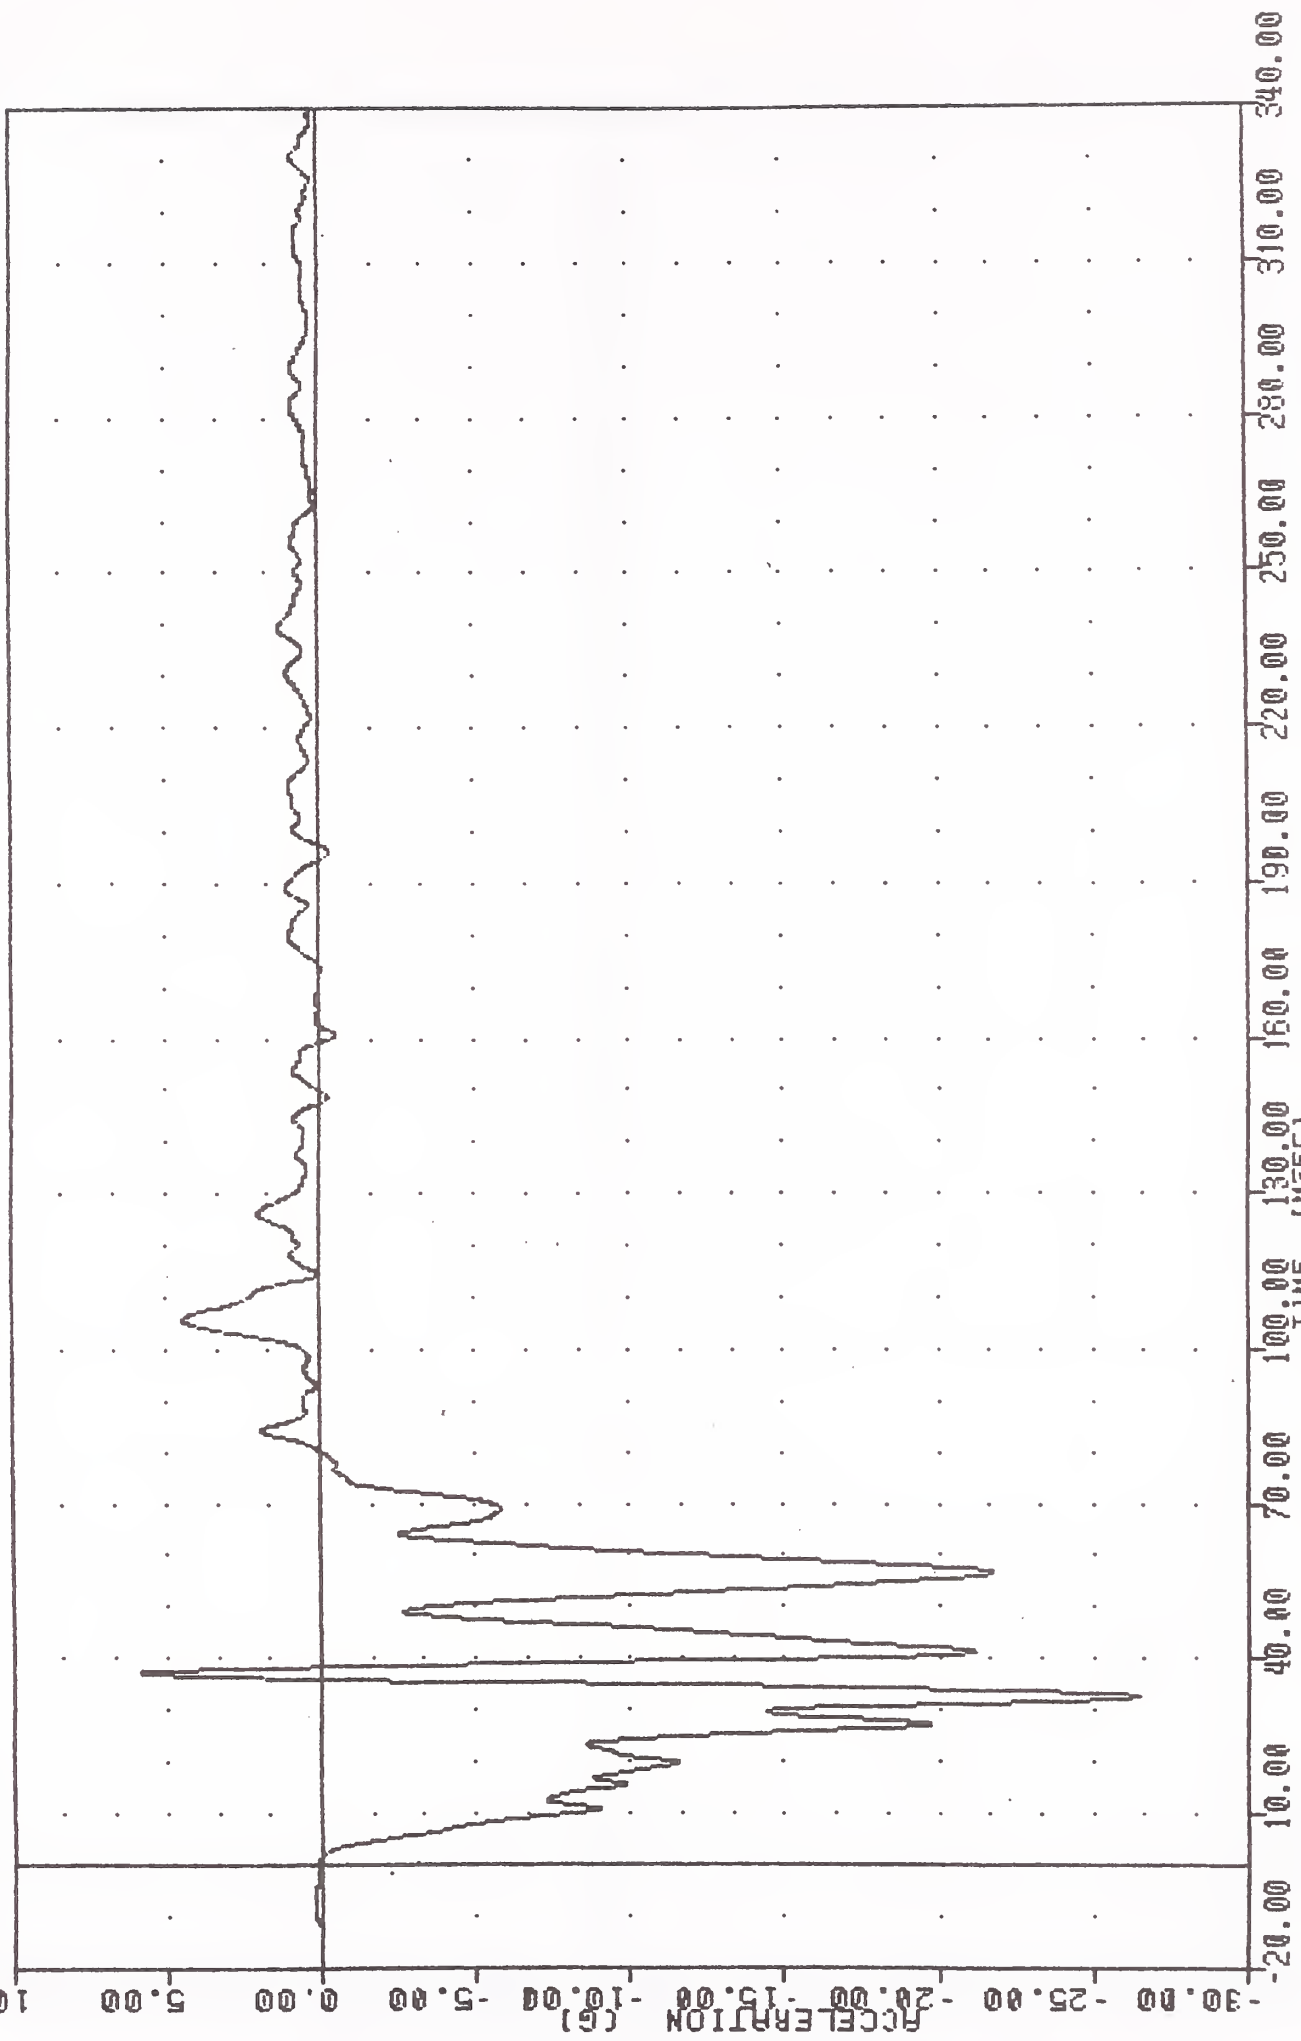
CONTOURED MOVING BARRIER INTO FORD ESCORT AT 28.1 MPH #2
VEHICLE CG X-AXIS ACCELERATION (IMPACT DIRECTION)

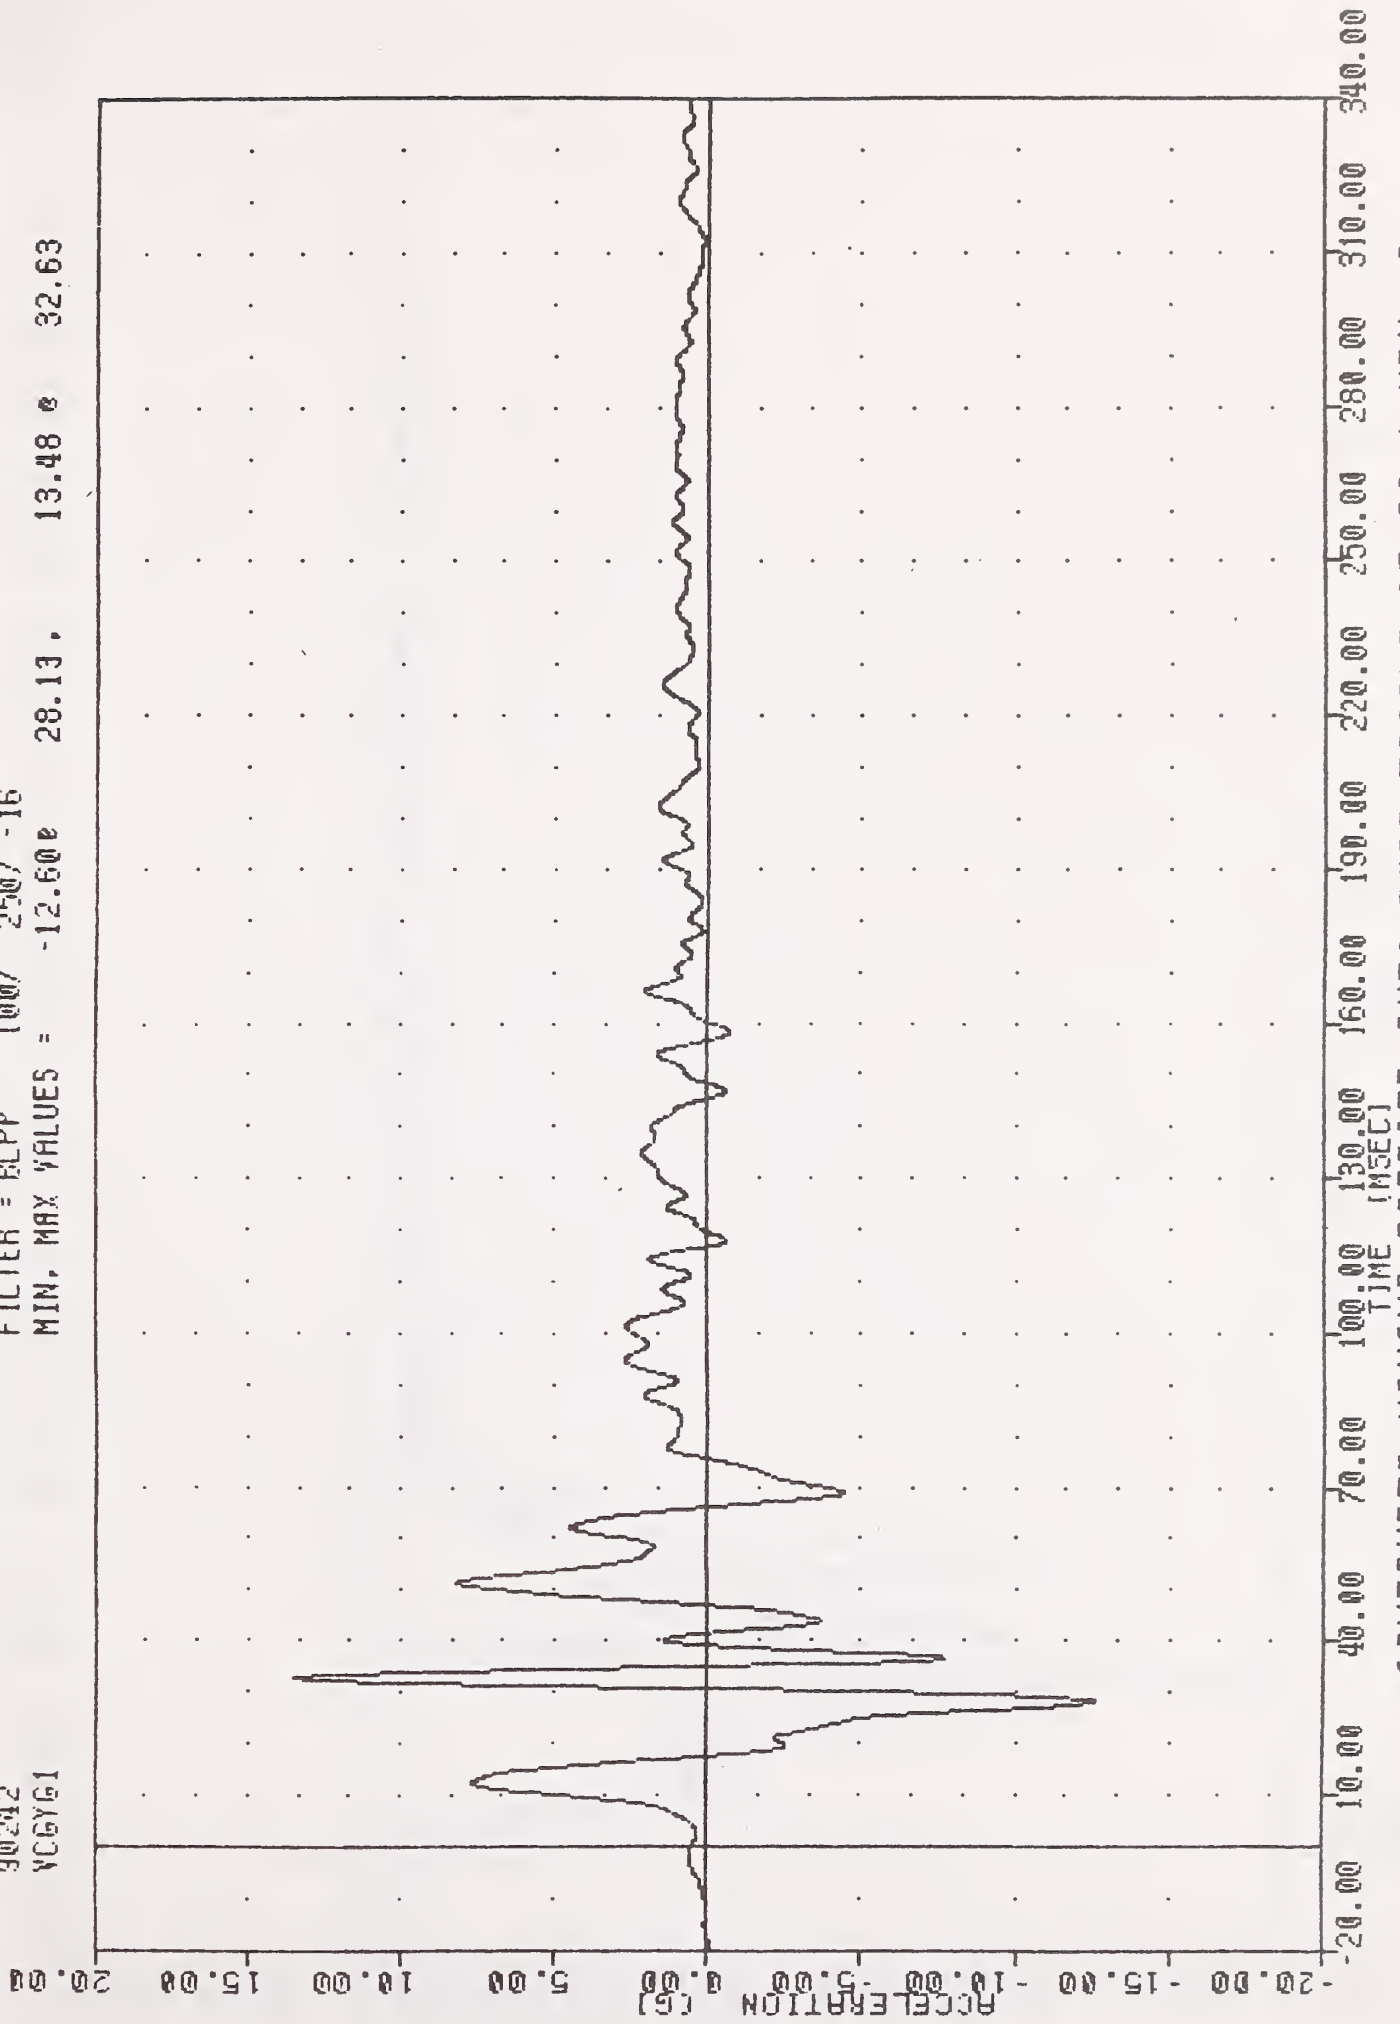
CONTOURED MOVING BARRIER INTO FORD ESCORT AT 28.1 MPH #2
 VEHICLE CG Y-AXIS ACCELERATION (PERPENDICULAR TO IMPACT DIRECTION)

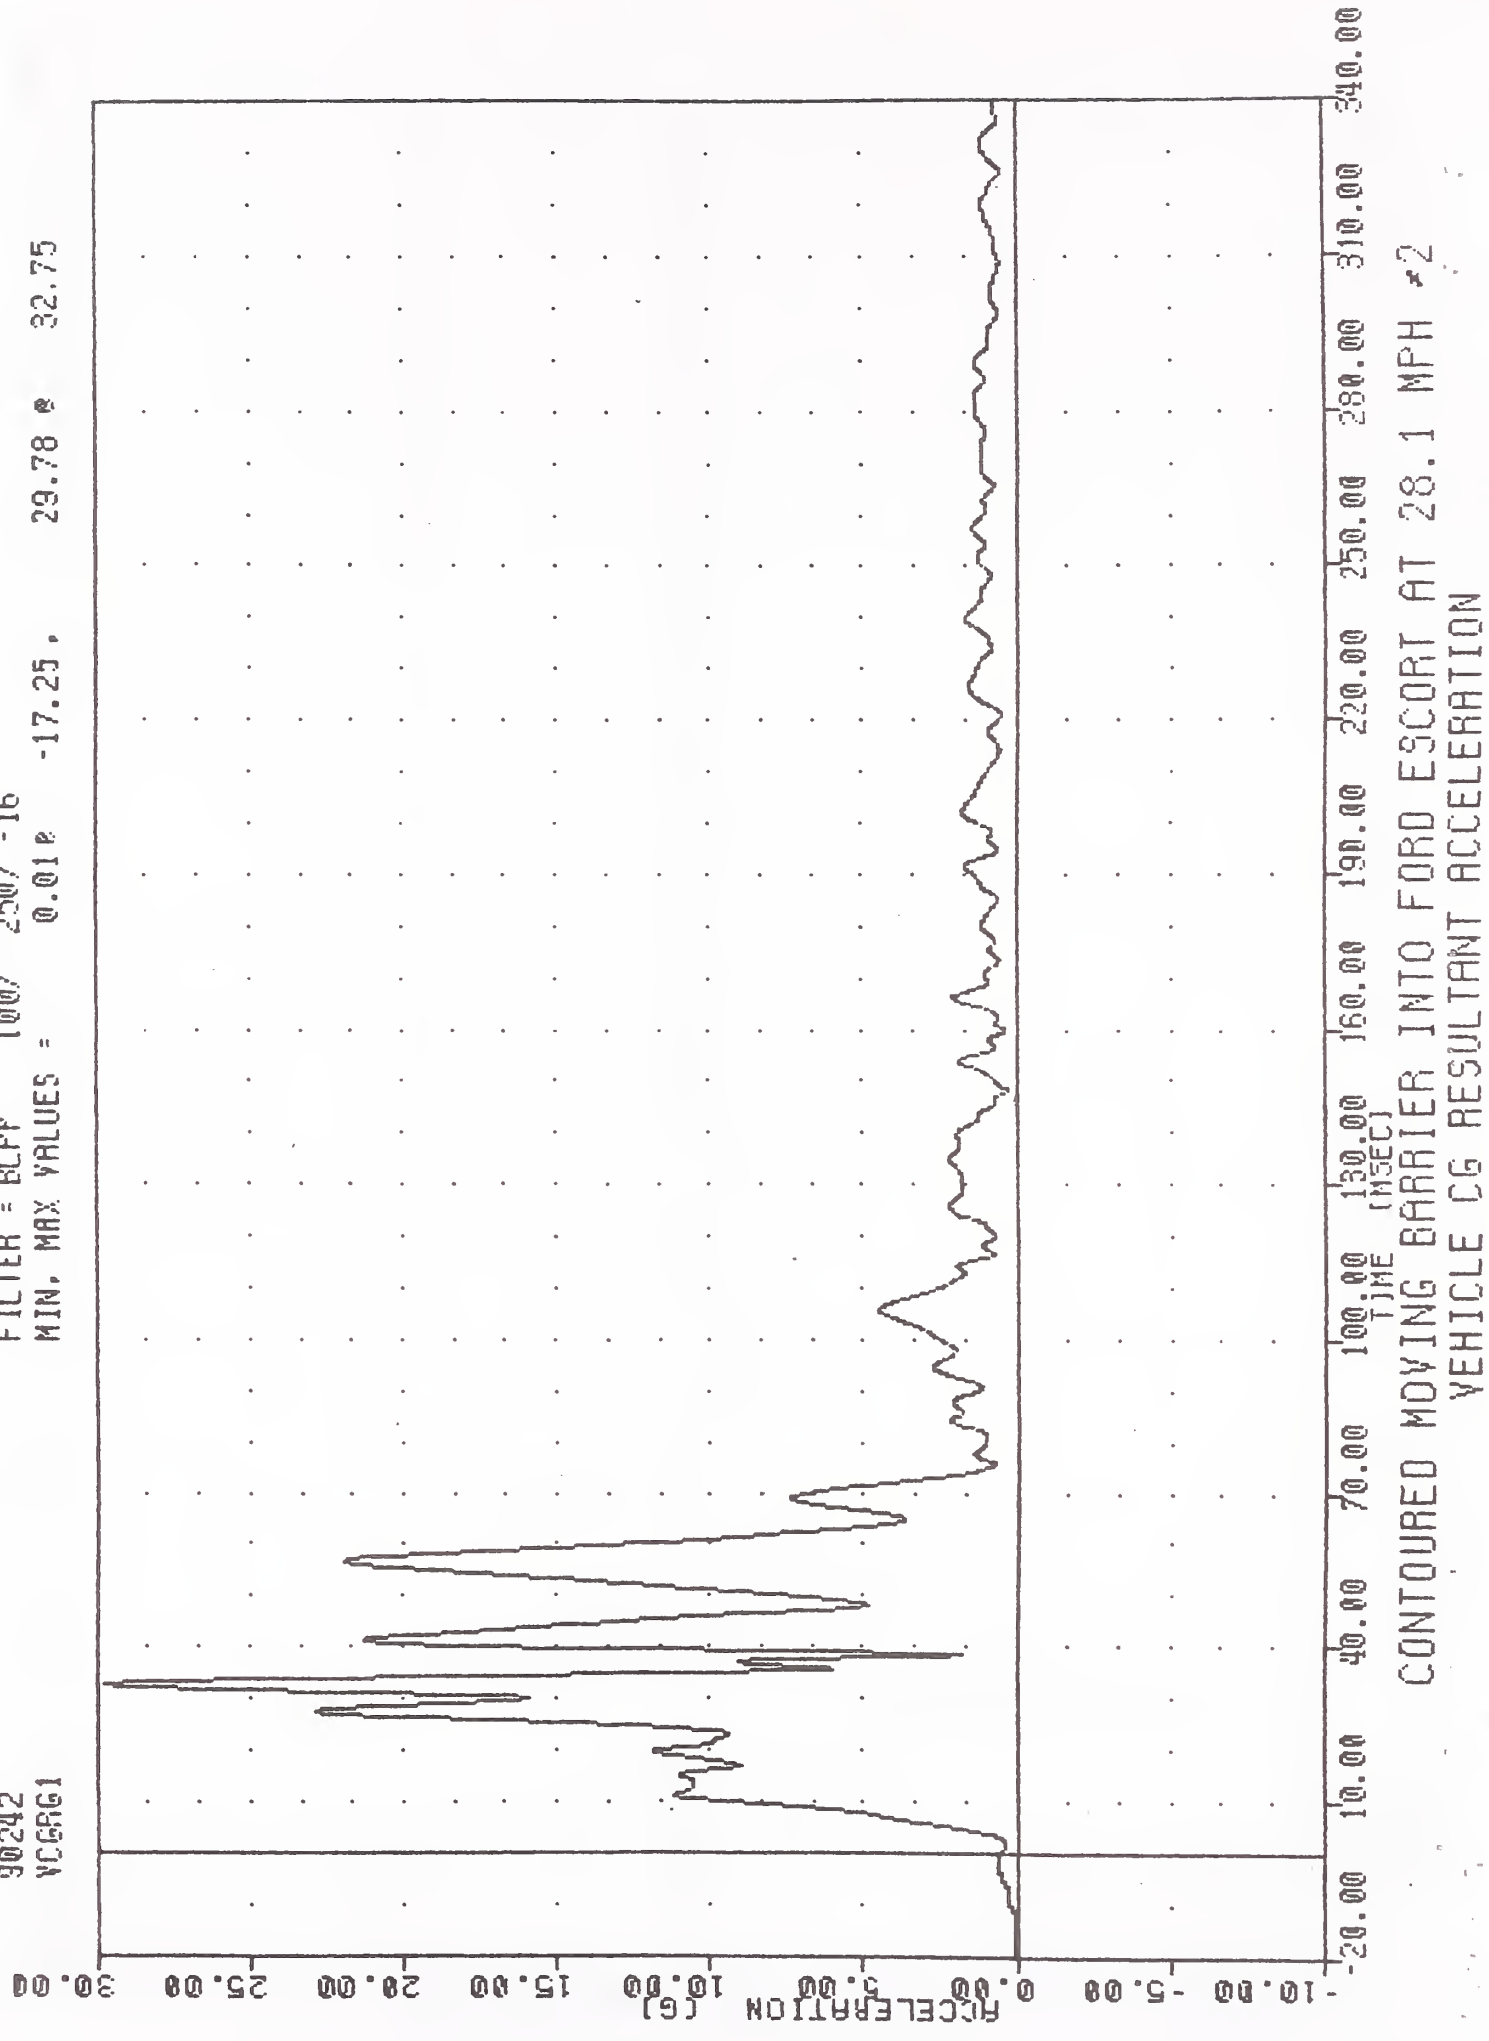
900820-2, TRC
 CRASH III DAMAGE ALGORITHM
 90242
 BCGXG
